Phantom QA Results: 32 CH

Date:03/18/2019

Dartmouth Brain Imaging Center (DBIC)

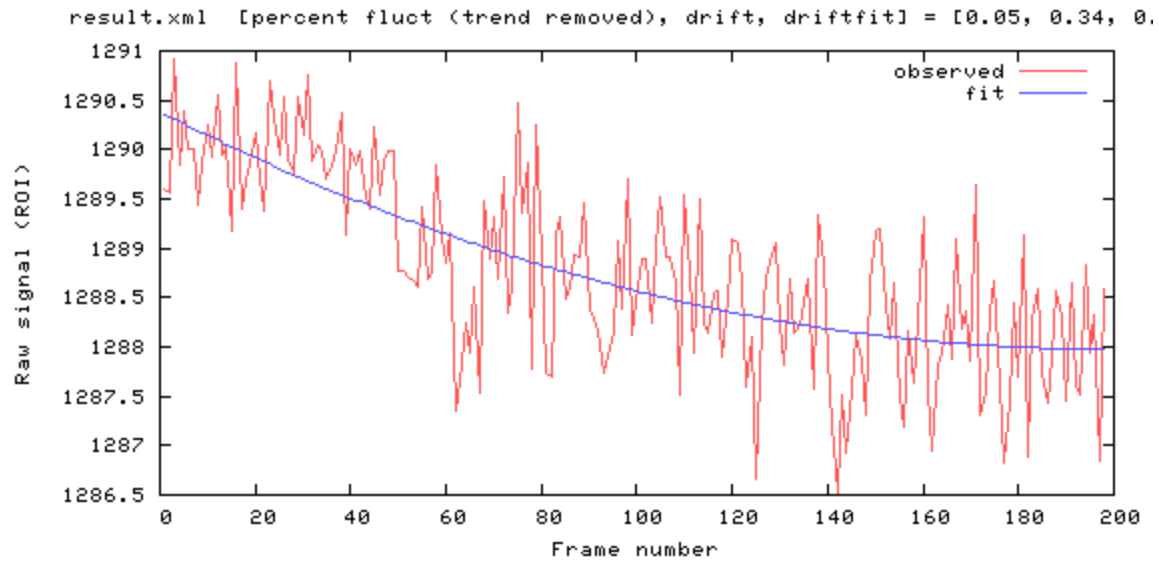
Figure 1

result.xml [percent fluct (trend removed), drift, driftfit] = [0.05, 0.34, 0.

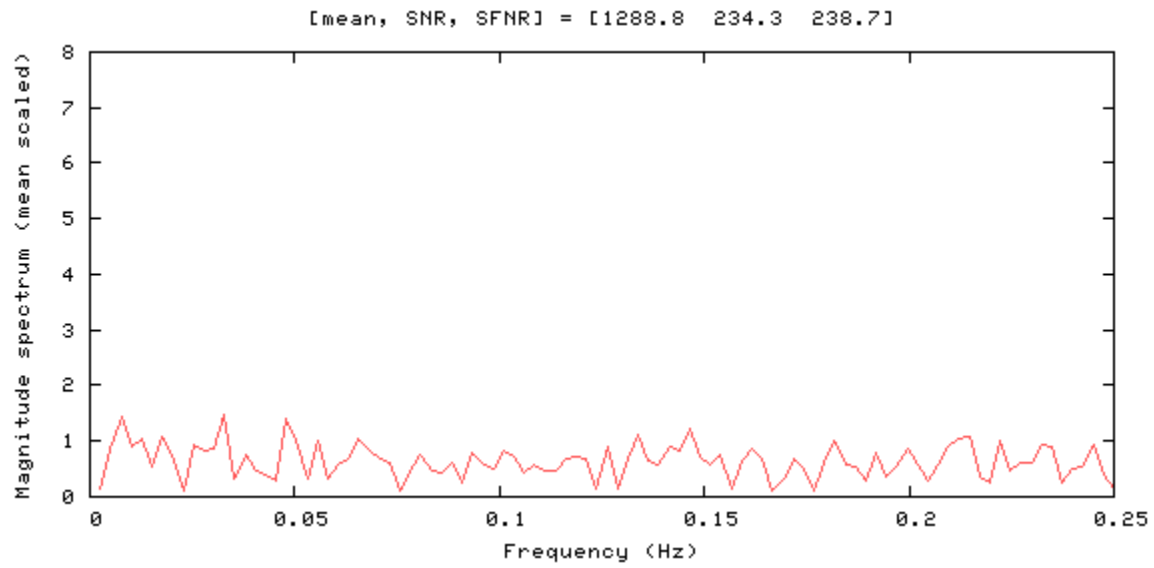
Figure 2

[mean, SNR, SFNR] = [1288.8 234.3 238.7]

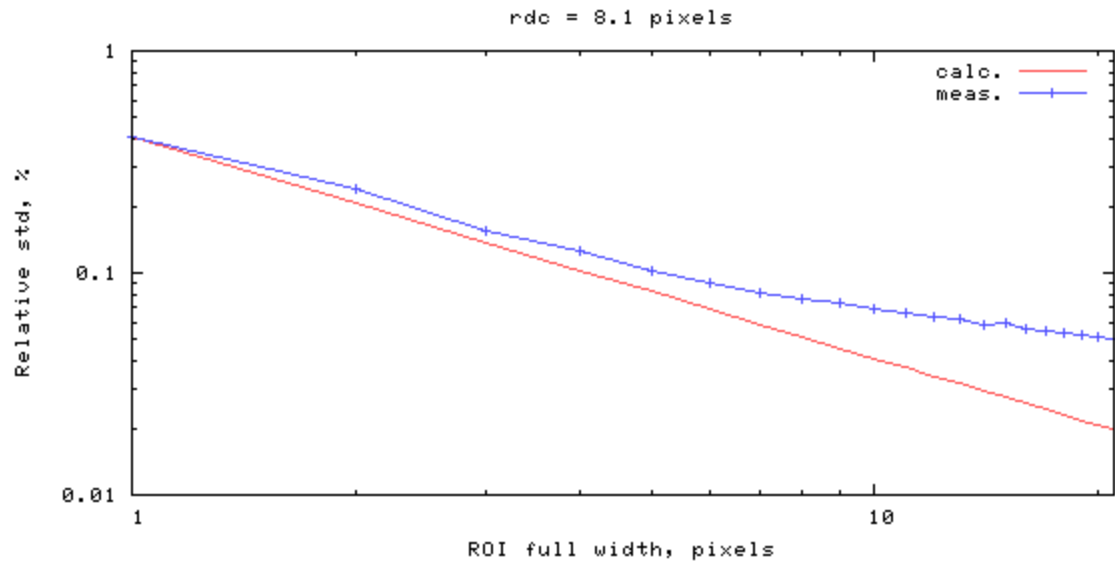
Figure 3

rdc = 8.1 pixels

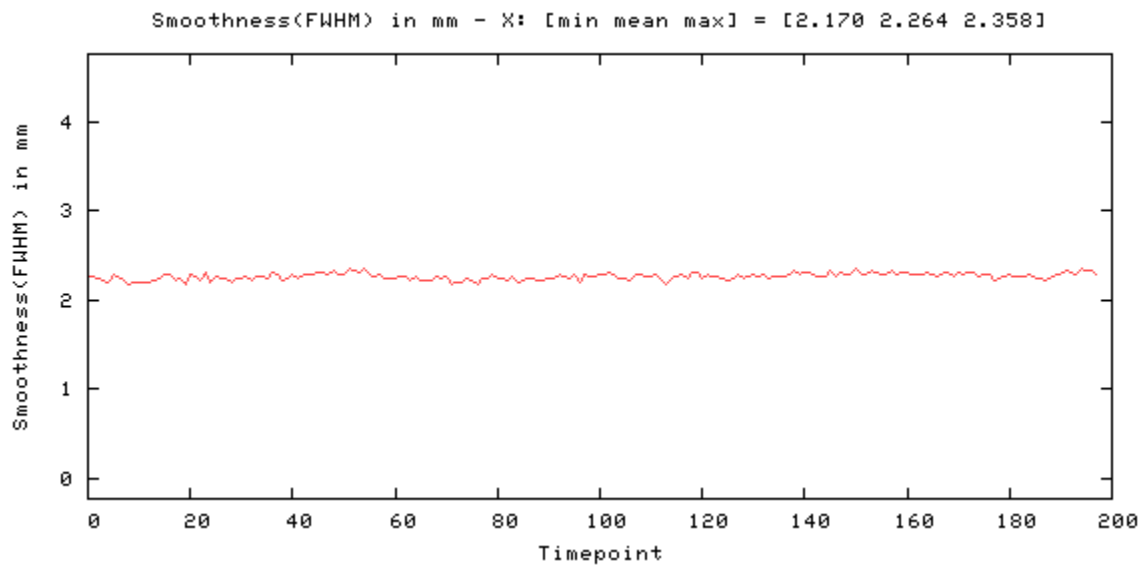
Smoothness(FWHM) in mm - X: [min mean max] = [2.170 2.264 2.358]

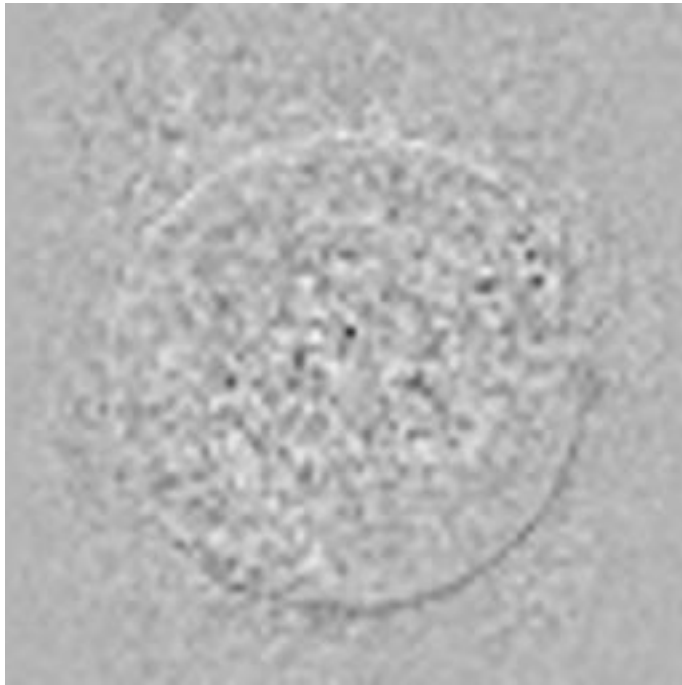
Figure 12

image min: 0, image max: 1844.22

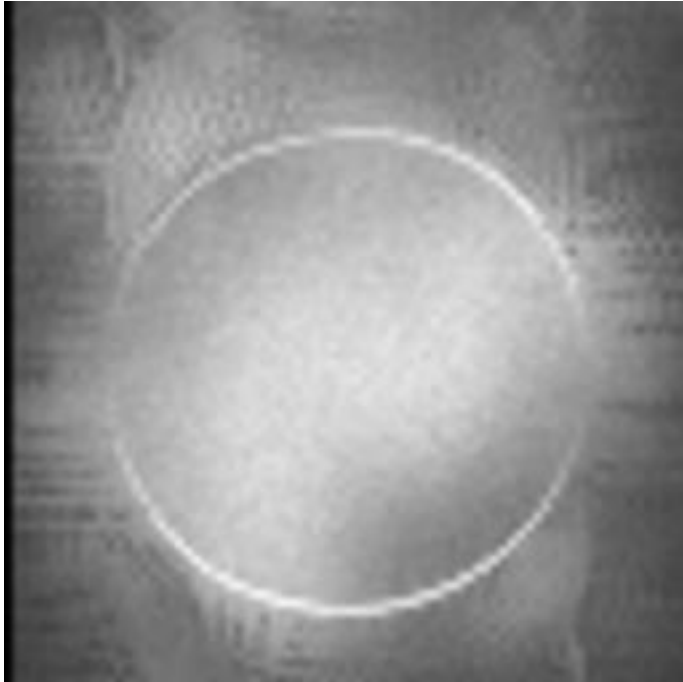
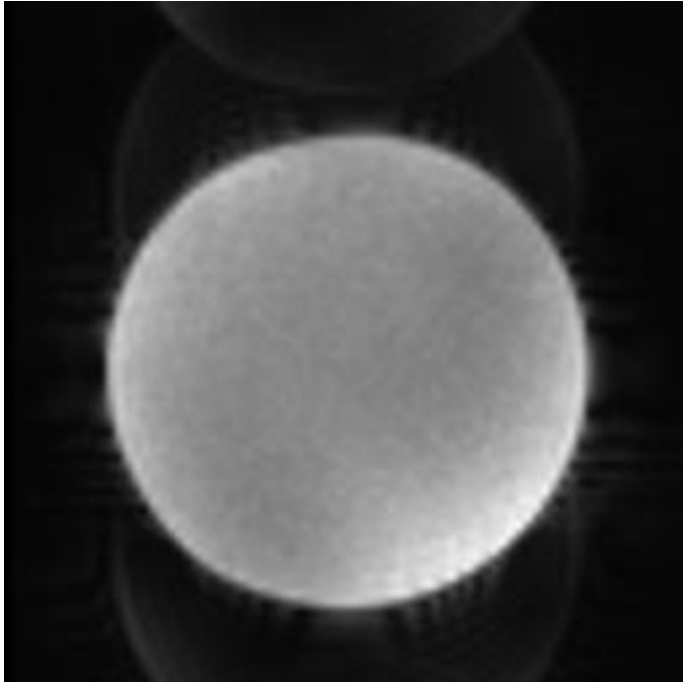
Figure 13

image min: 0, image max: 7.81487
